The Service Group

November 2009 Monthly Technical Bulletin

Subj: URGENT Maxxim Z axis issues

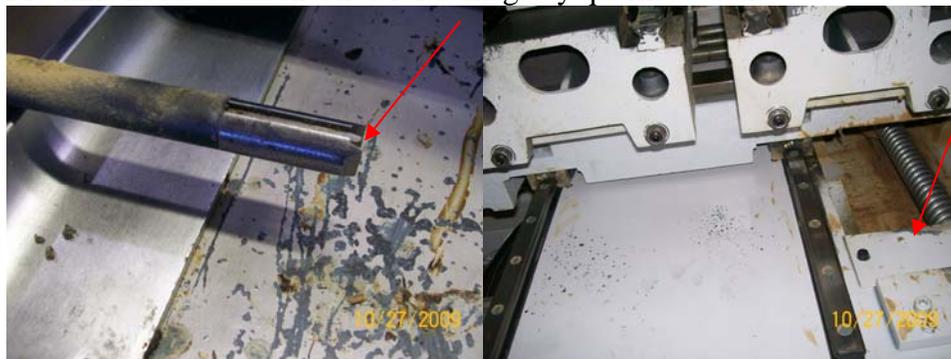
Over recent months I've been doing an engineering investigation into the primary causes for the Z axis crashes on this specific machine. The primary cause for failure is improper shut down procedures (Machine being left on over night with air turned off). During my investigation I've also found several serious machine issues that need to be addressed.

Z axis lock pin assembly

1. Found Z balance cylinder exhaust ports plugged and mufflers bad causing over pressurization of air cylinder. Solution: Change out mufflers with AN300 or AN400 once a year.
2. Due to location of lock pin assembly at lower base of Z axis, Lock pin assembly must be kept cleaned out on weekly basis. More info contact TSG.
3. If your Maxxim Z axis has crashed to the table, most likely the Z lock pin will need to be replaced. Recently I've determined that the center tooth on the lock pin assembly is being worn down by the spiraling affect of the Z crash and is hard to determine with pin in machine. Recommendation: Remove and replaced lock pin ASAP to prevent further damage to machine. Call TSG for Info.
4. Machine needs to be checked for damage by qualified tech.
