SHODA CNC APRIL 2011 MONTHLY TECHNICAL BULLETIN

SUBJ: Table bearings.

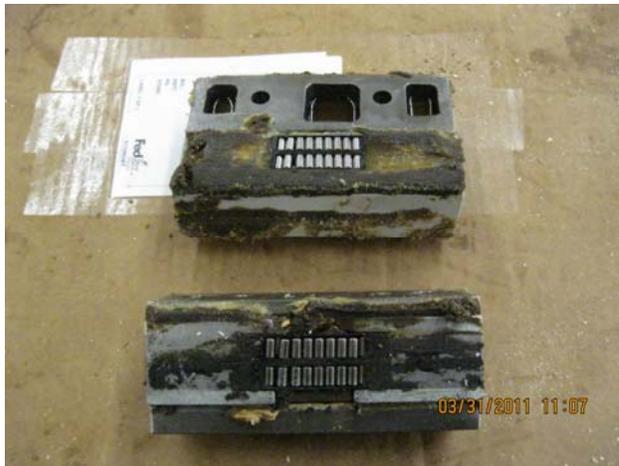
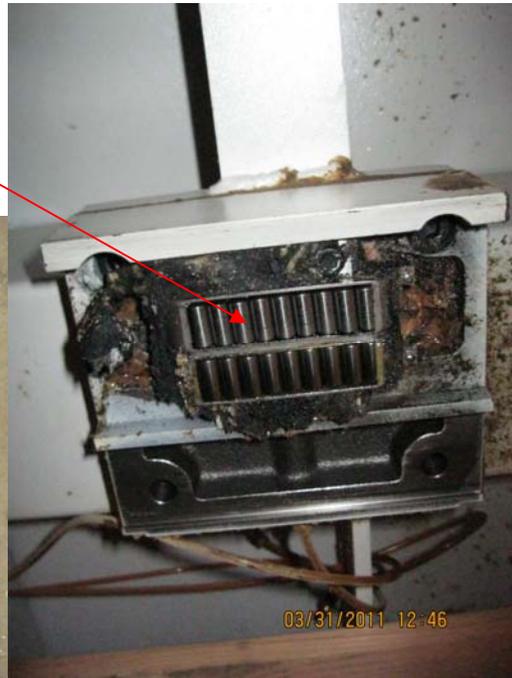
Note: that the bearings are dry with grease around the bearing.

There are a lot of machines that are older than 10 years and haven't had any work to their tables. The table are the most used axis and the most susceptible to debris damage. We would recommend a bearing change if you've had greasing failure in the past or if you still have the original bearings.

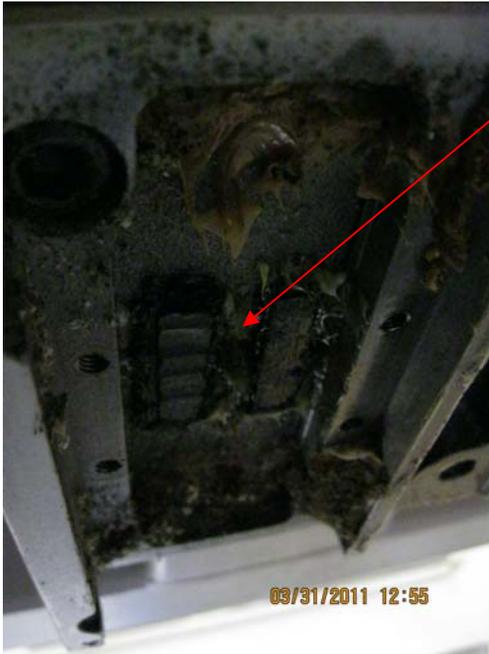
Note: Debris or solidified grease packs behind the bearing as shown and stops flow of new grease into bearings especially if incorrect grease has been used.

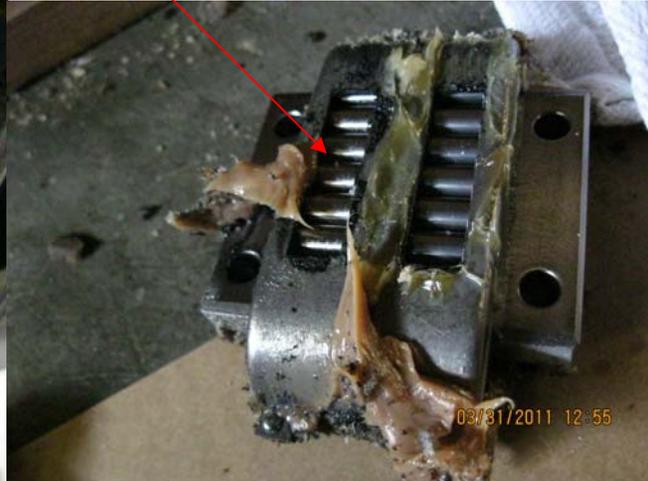
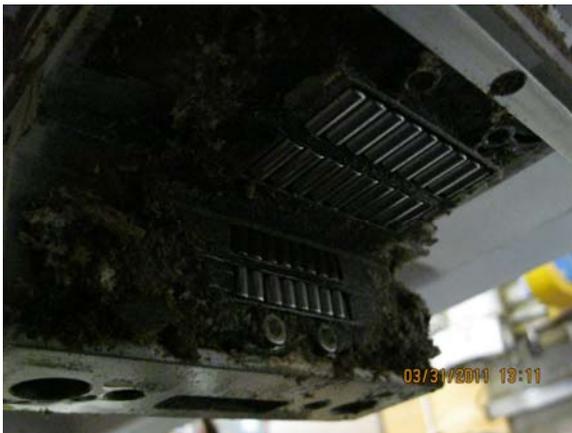
- Lack of grease causes premature wear to axis rails. We would recommend that bearings be replaced, grease fittings be flushed and then the table has to be properly tensioned.

If you need to replace the bearings on your tables please ensure you order the bearings well in advance due to a possible lead time on the top side larger bearings.
